## **Fort Leonard Wood Lake of the Ozarks Recreation Area, NRHP Section 110 Inventory and Evaluation**

Sunny E. Adams and Adam D. Smith

June 2016

Final report

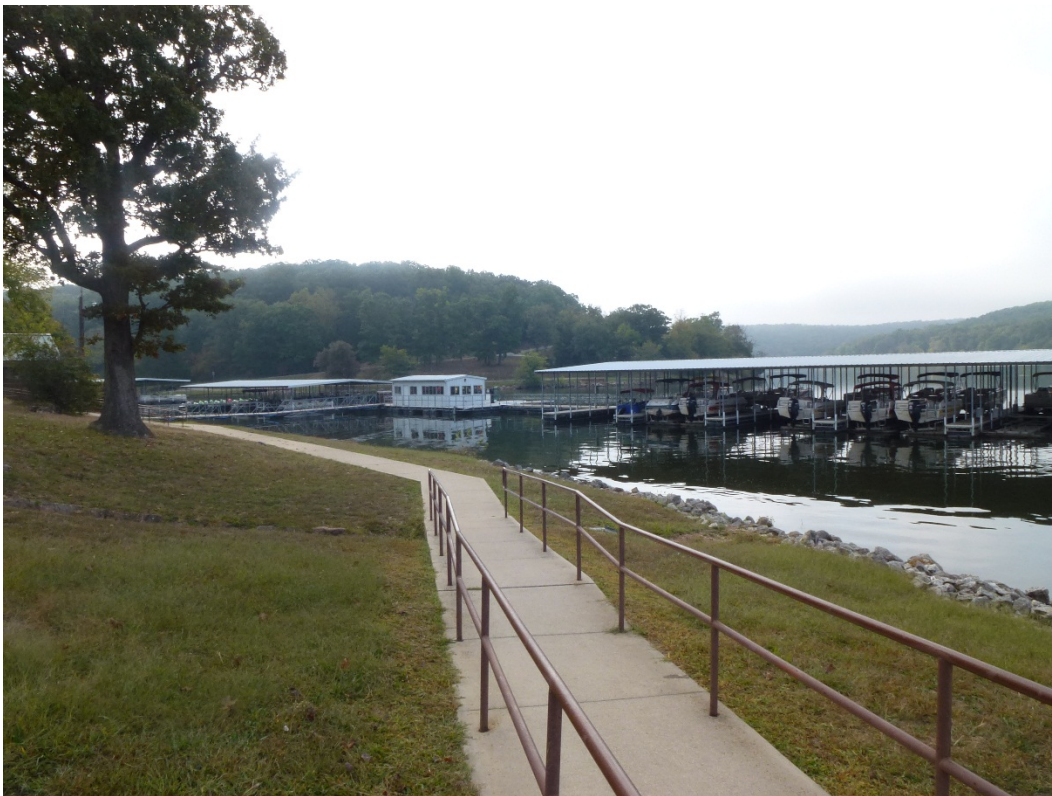
Figure 114. Newer concrete sidewalk with metal handrails that leads from the paved parking lot near the marina to Building 528 and the marina (ERDC-CERL, 2015).

The LORA site sits up on a bluff overlooking the lake. A number of poured concrete sets of steps with metal pipe handrails were constructed in the early years of LORA, circa 1961, in order to help provide access for the guests from the “trailer sites” [now cabins] down to the lakeshore, recreation shelter, swimming area, and marina. Several of these long sidewalk/steps are still intact (Figure 111 and Figure 112). There have been a few newer sidewalks added at later dates to help with the circulation pattern and ease of getting around LORA (Figure 113 through Figure 115).

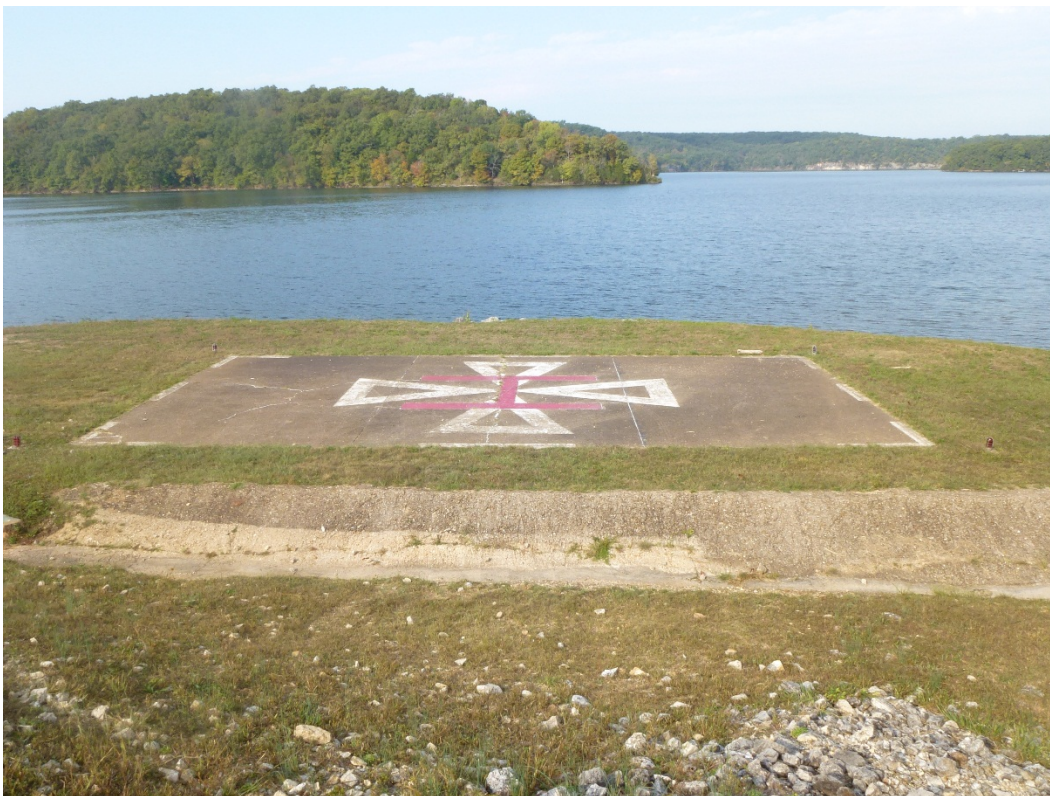
Building 548 (rotary wing landing pad, pavement), was constructed as a helipad in 1961. The pad is located on a flat piece of land on the west side of the LORA site near the shoreline. It is accessible via a paved driveway. Buildings 550 and 555 are to the east, Building 549 is to the north, and the boat launching ramp is to the south. The helipad is constructed of a concrete pad and is square in shape. The letter “H” is painted on the concrete as well as four triangles (Figure 116).

Figure 116. Helipad site (ERDC-CERL, 2015).

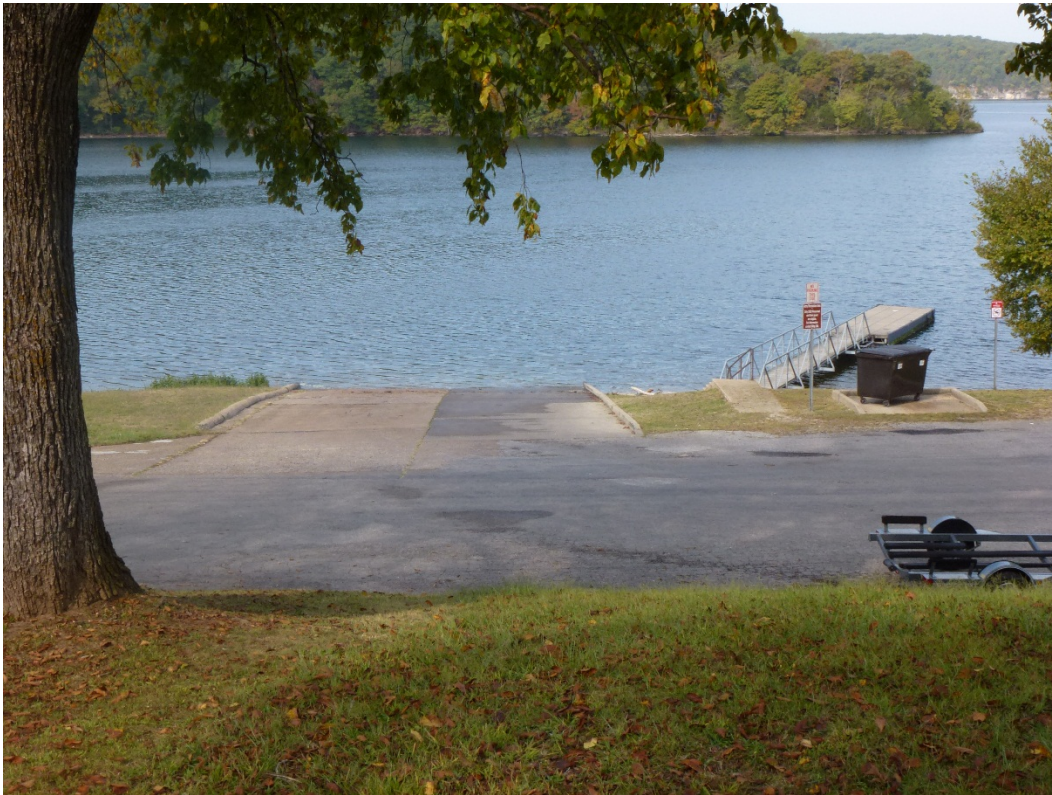
There is a poured concrete boat-launching ramp located on the east side of the LORA site. A large paved lot is adjacent to the ramp for boat turnaround (Figure 117).

Figure 117. Boat-launching ramp (ERDC-CERL, 2015).

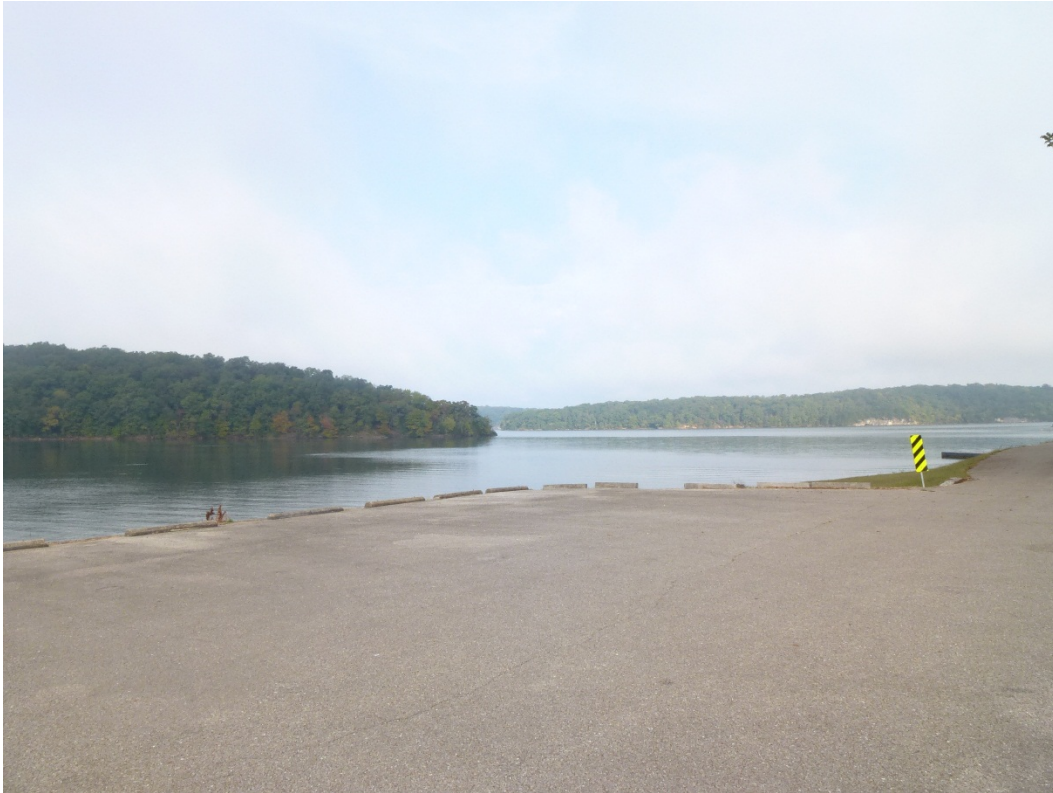
There are only a few areas for parking at LORA. These areas are both paved and unpaved. It is unclear if the parking lot nearest the marina was originally a gravel lot or if it was paved later (Figure 118). There is also a paved lot near the boat launching ramp, where trailers can park. There is an unpaved lot near Building 549 (recreation shelter; Figure 119).

Figure 118. Paved parking lot near the marina (ERDC-CERL, 2015).

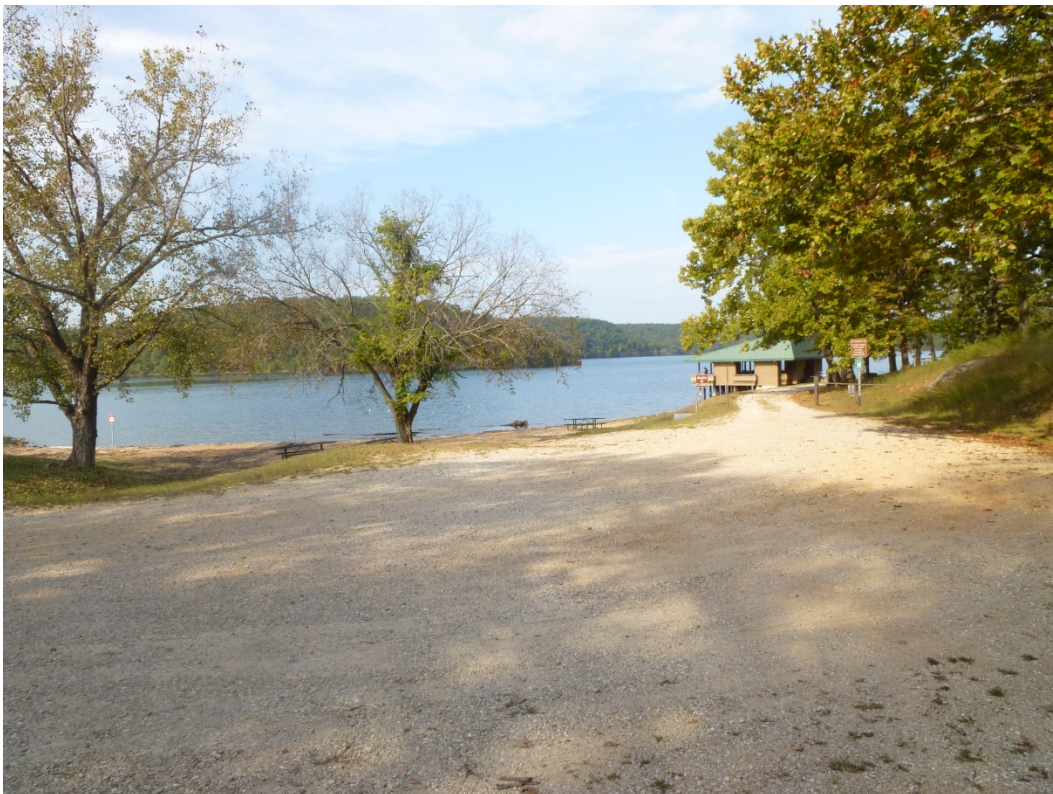
Figure 119. Unpaved parking area located near Building 549 (ERDC-CERL, 2015).

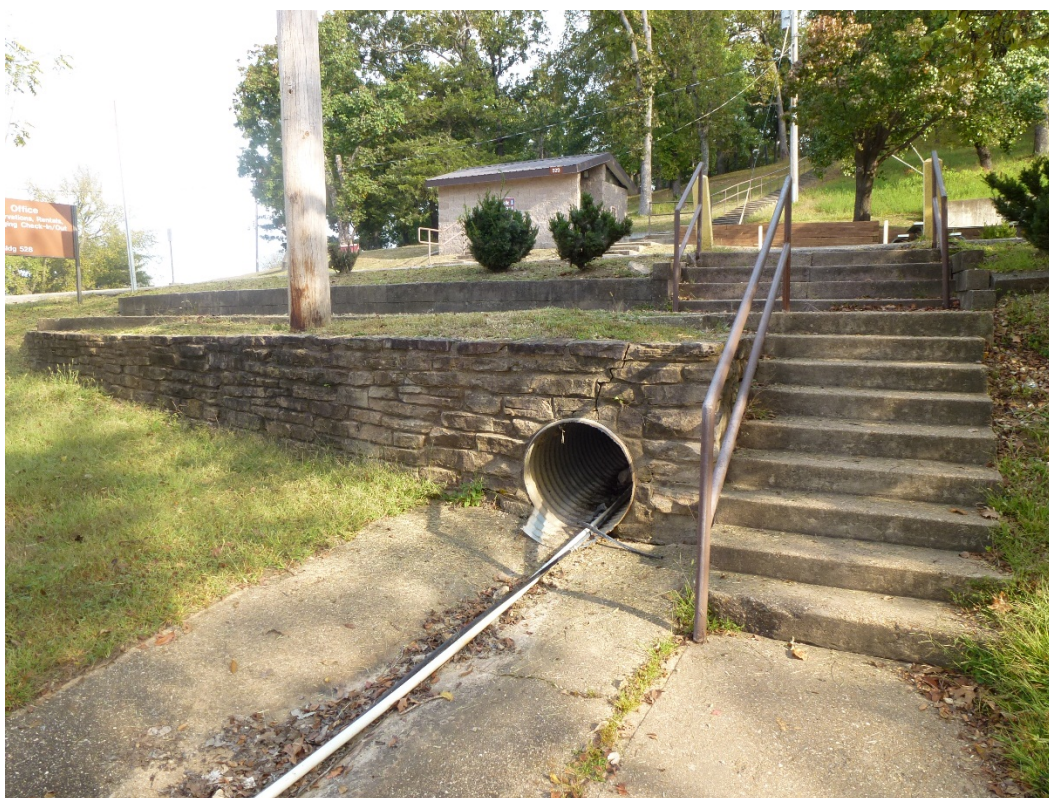
Since LORA is located on a hillside/bluff overlooking the lake, there are several retaining walls constructed to support the hill near buildings, walkways, and roads. Many of these walls are simply constructed of poured concrete. A few are constructed of stonework, but the newer walls are constructed of concrete block (Figure 120 and Figure 121).

Figure 120. Stonework retaining wall constructed near Building 528 (ERDC-CERL, 2015).

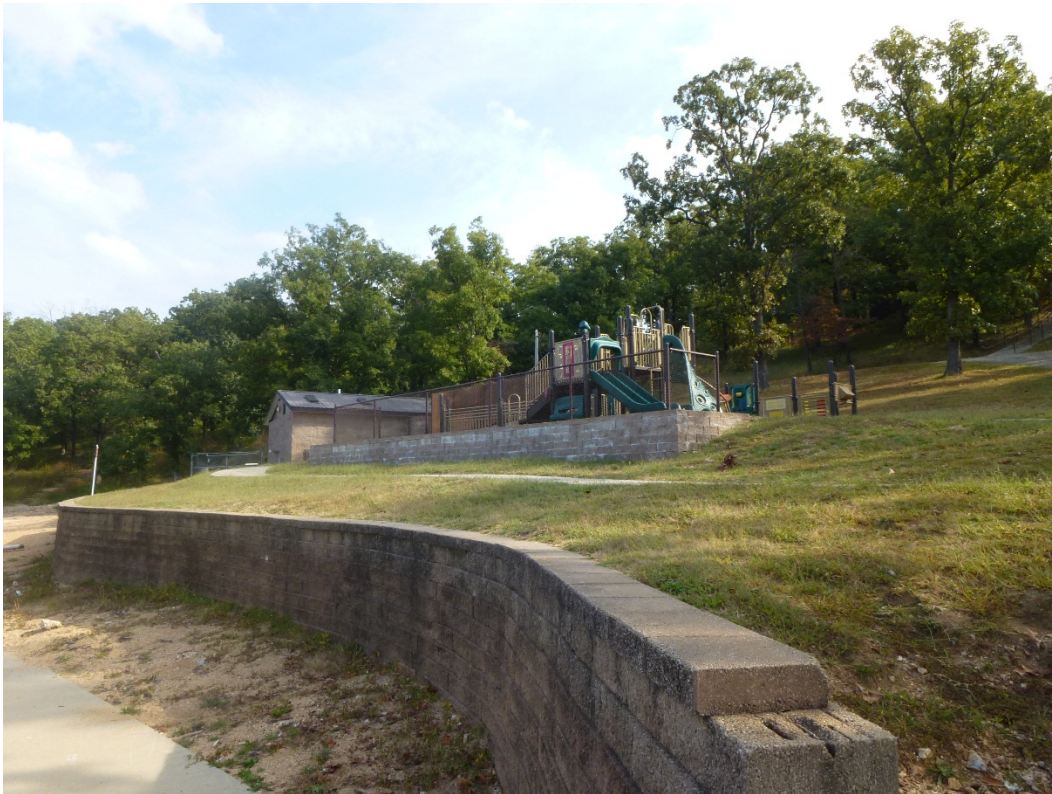
Figure 121. Newer concrete-block retaining wall near the swimming area (ERDC-CERL, 2015).

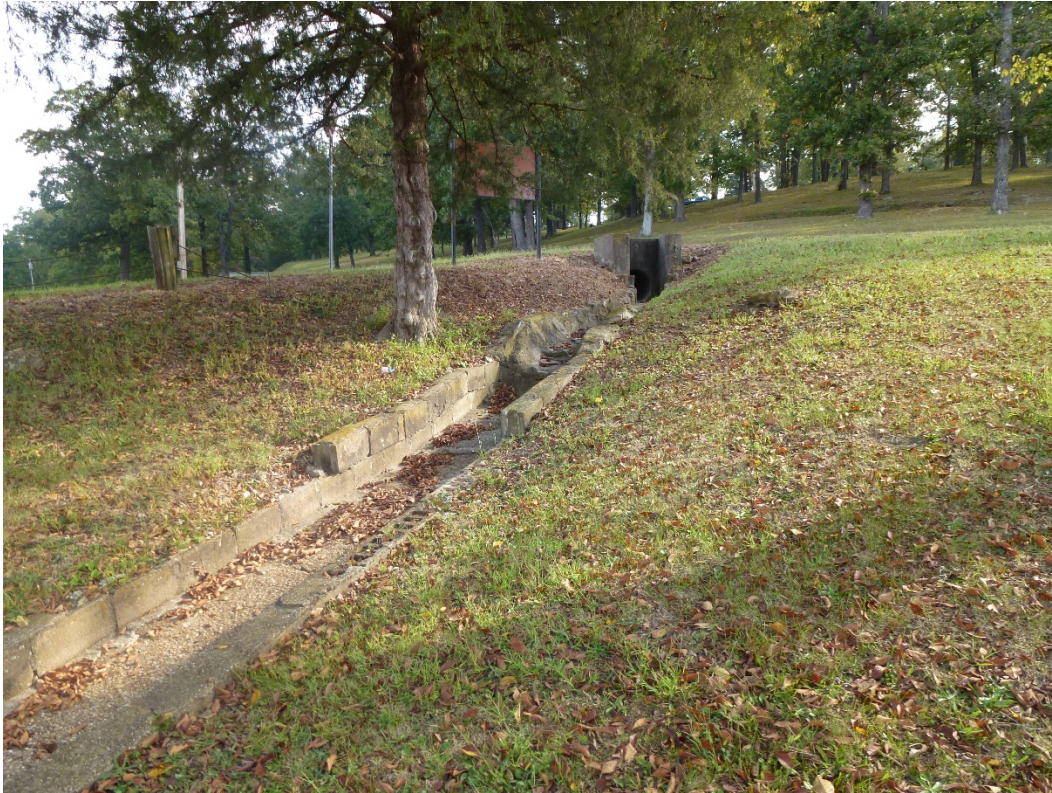
LORA is set on a hilly bluff overlooking the Lake of the Ozarks. Some permanent-type drainage ditches were constructed to divert water away from the buildings and down the hillside (Figure 122).

Figure 122. Concrete ditch located near Building 528 (ERDC-CERL, 2015).

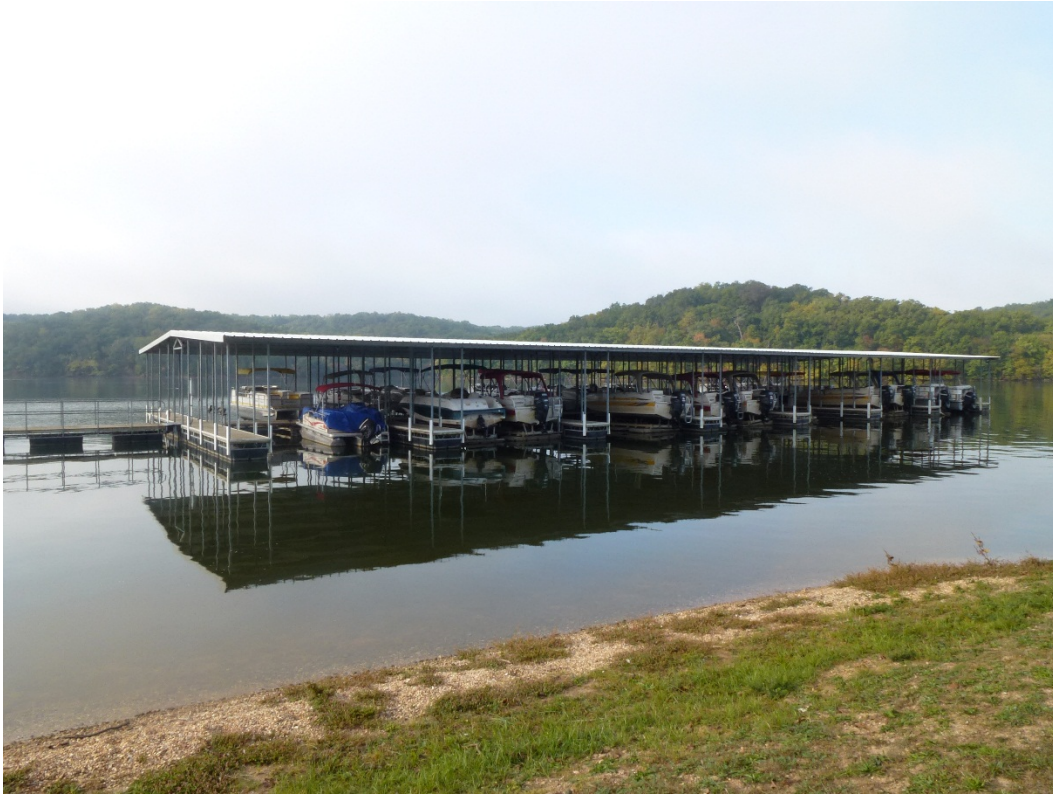
There are three large, floating docks located at the marina. These docks provide boat slips and storage for LORA guests (Figure 123, Figure 124, and Figure 125). Another smaller floating dock is located at the northern end of LORA, closest to the rental cabins and is accessible by a set of concrete steps. A small floating pier is located at the boat launching ramp (Figure 126).

Figure 123. Floating dock at the marina (ERDC-CERL, 2015).

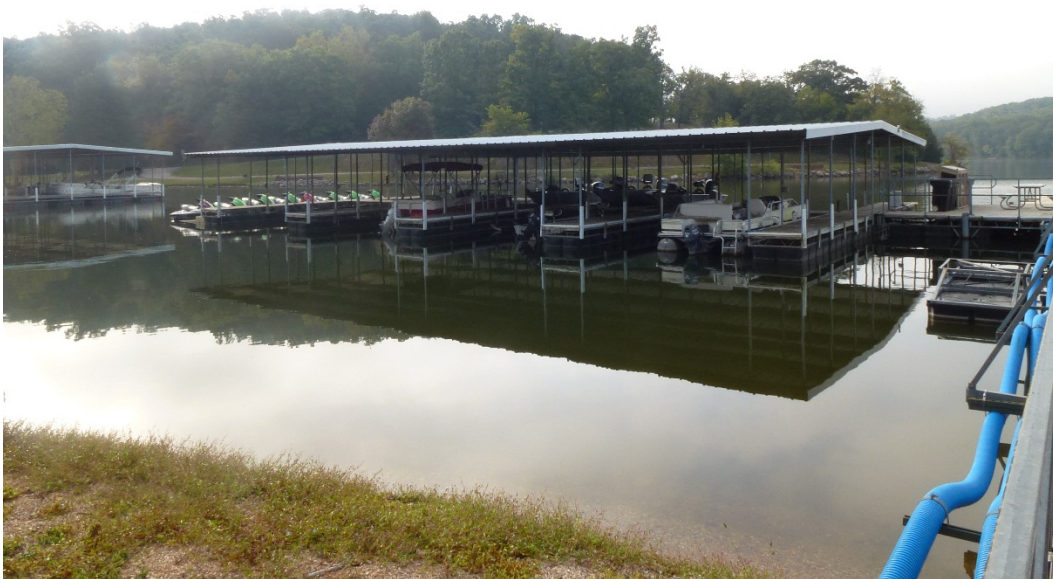
Figure 124. Boat dock with storage slips at the marina (ERDC-CERL, 2015).

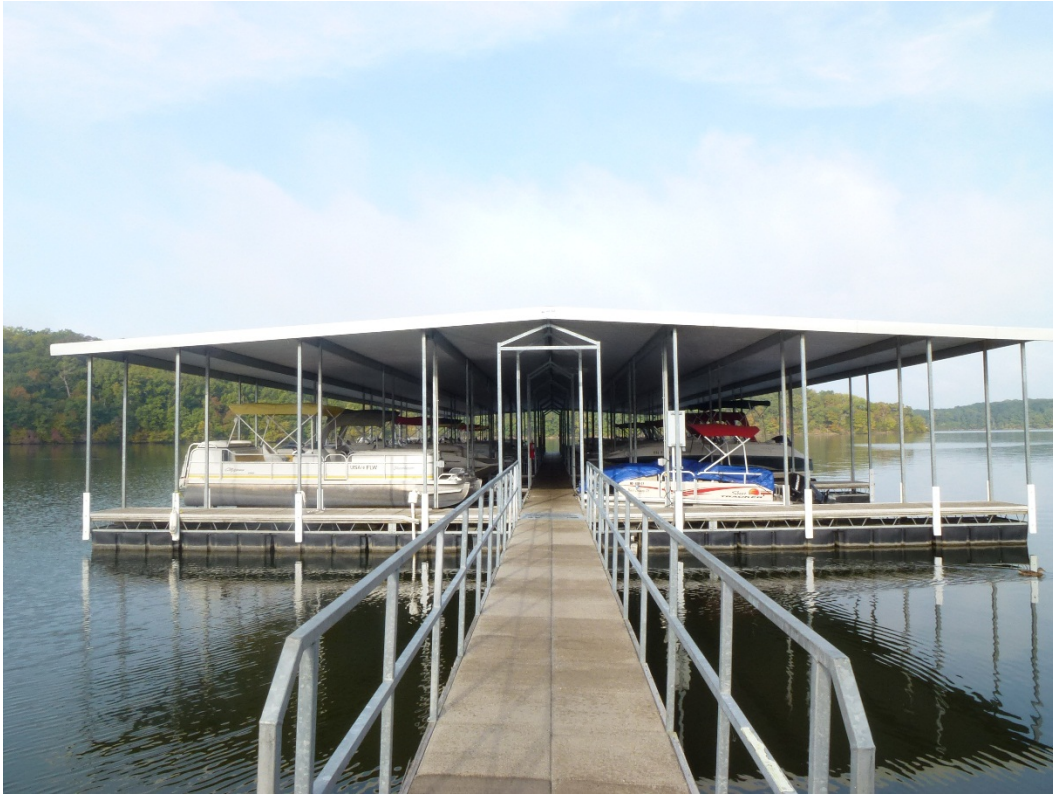
Figure 125. View of a floating dock at the marina (ERDC-CERL, 2015).

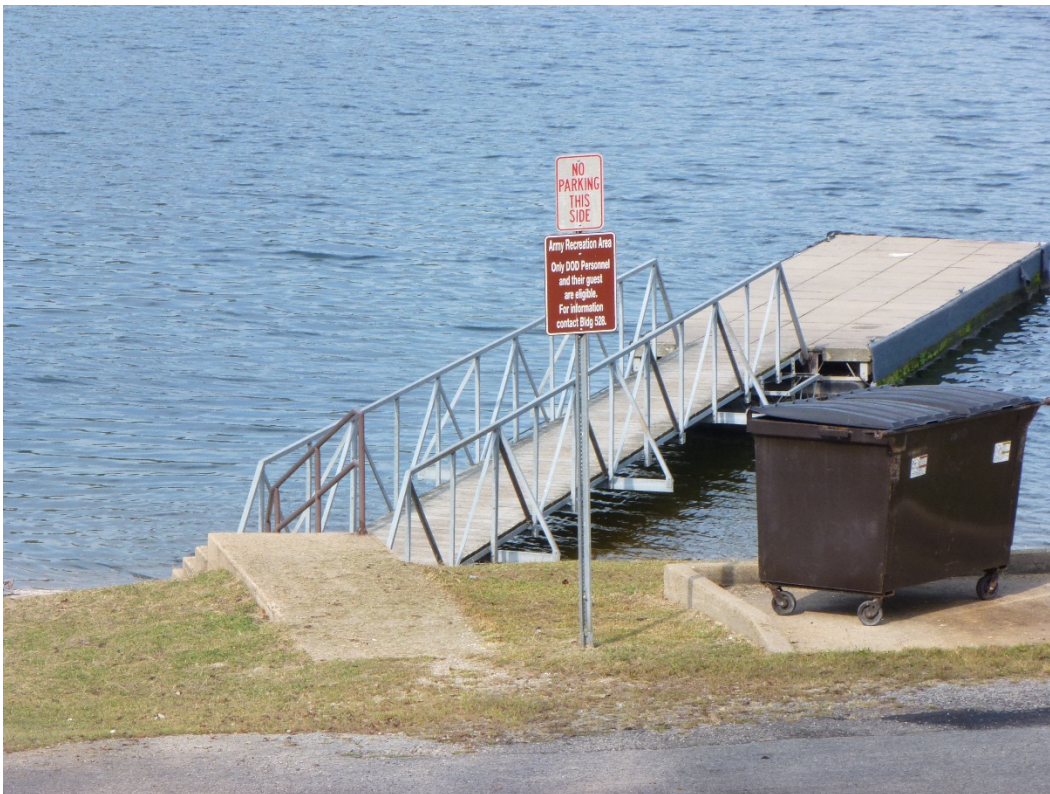
Figure 126. Small floating dock located near the boat-launching ramp.

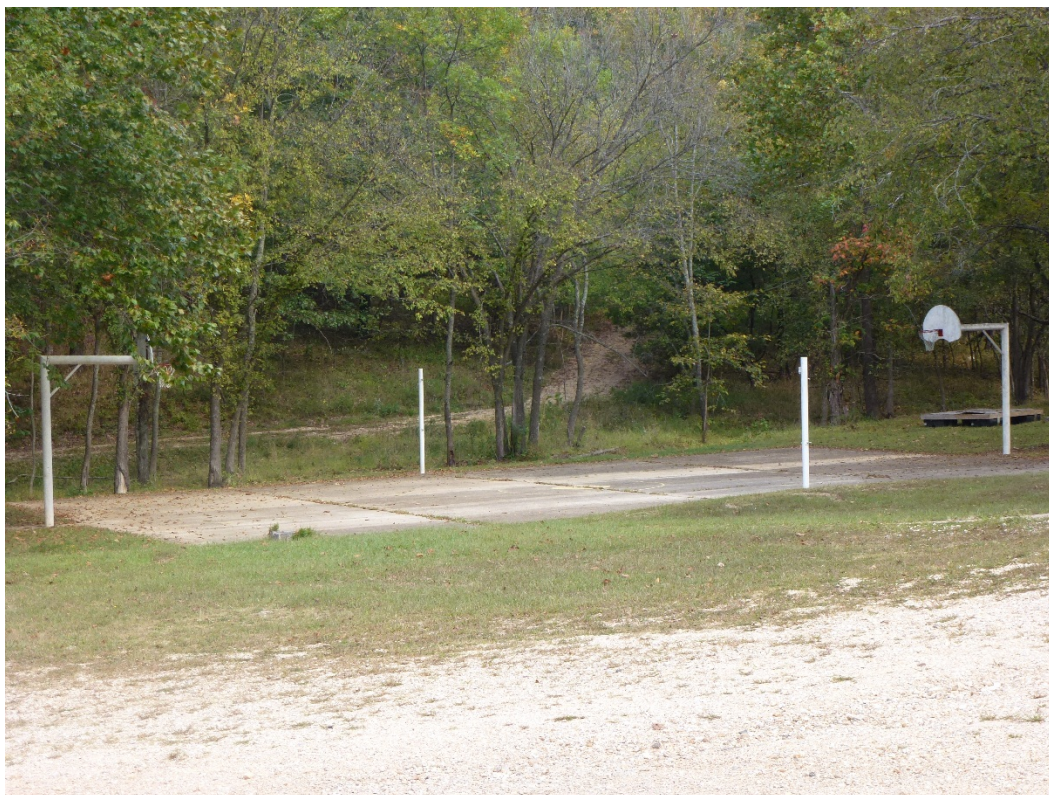
A poured-concrete court area (Figure 127 is located on the south side of LORA near Buildings 144 and 146. There are two basketball goals and poles set for a volleyball net. According to the Real Property list, this court is designated Building 141 (court area) and it is listed as being constructed in 1961; however, as late as 1978 a map indicates that a building (a day room) was located where this court is currently (Figure 128).

Figure 127. Basketball/volleyball court (ERDC-CERL, 2015).

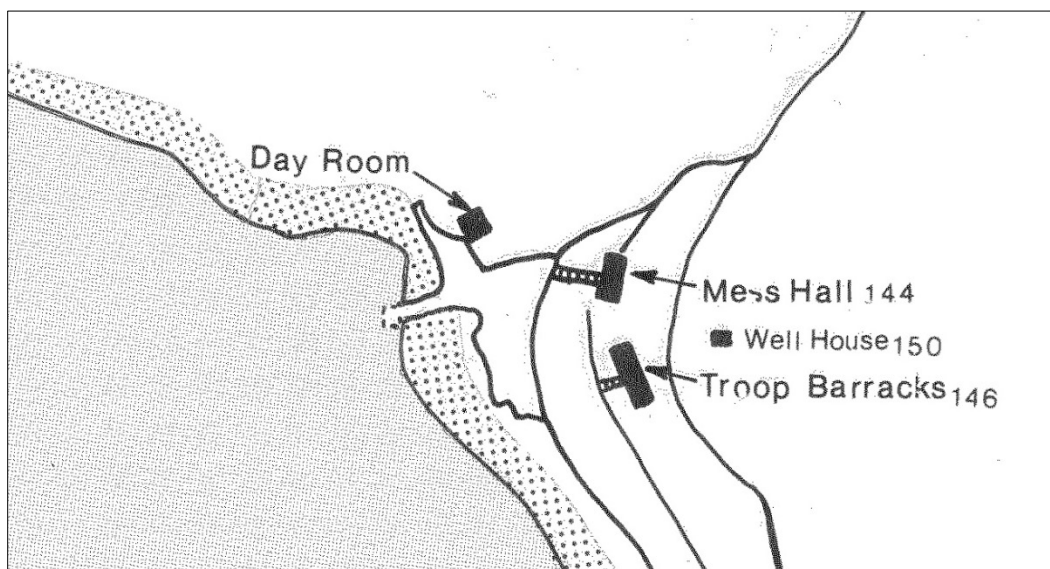
Figure 128. A 1978 map showing the location of the day room and not the court (DPW, FLW).

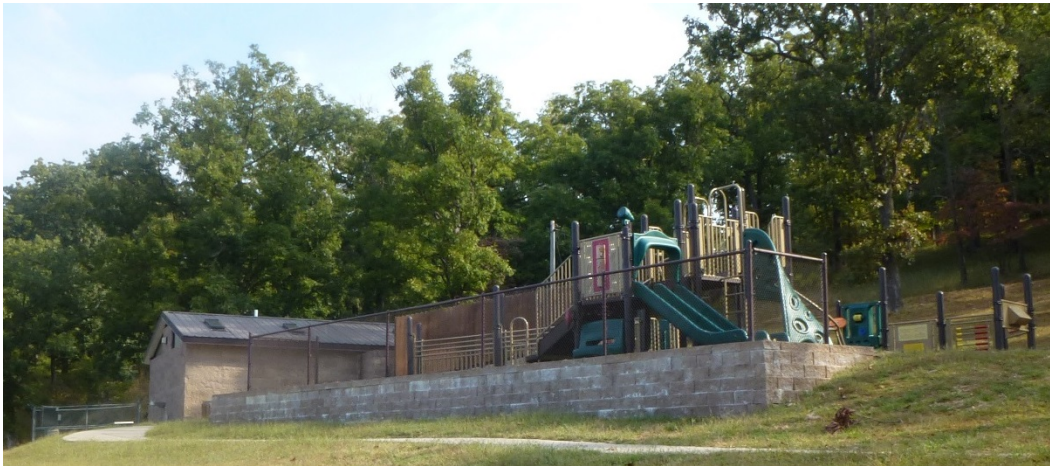
A newly constructed play-structure is located near the helipad and boat-launch ramp on the west side of LORA (Figure 131). The play area is nestled into the hillside and supported by a concrete-block retaining wall. A newly constructed bath house is located to the north.

Figure 131. Newer playground area located near the swimming area, with newer bath house to the left of the photo (ERDC-CERL, 2015).

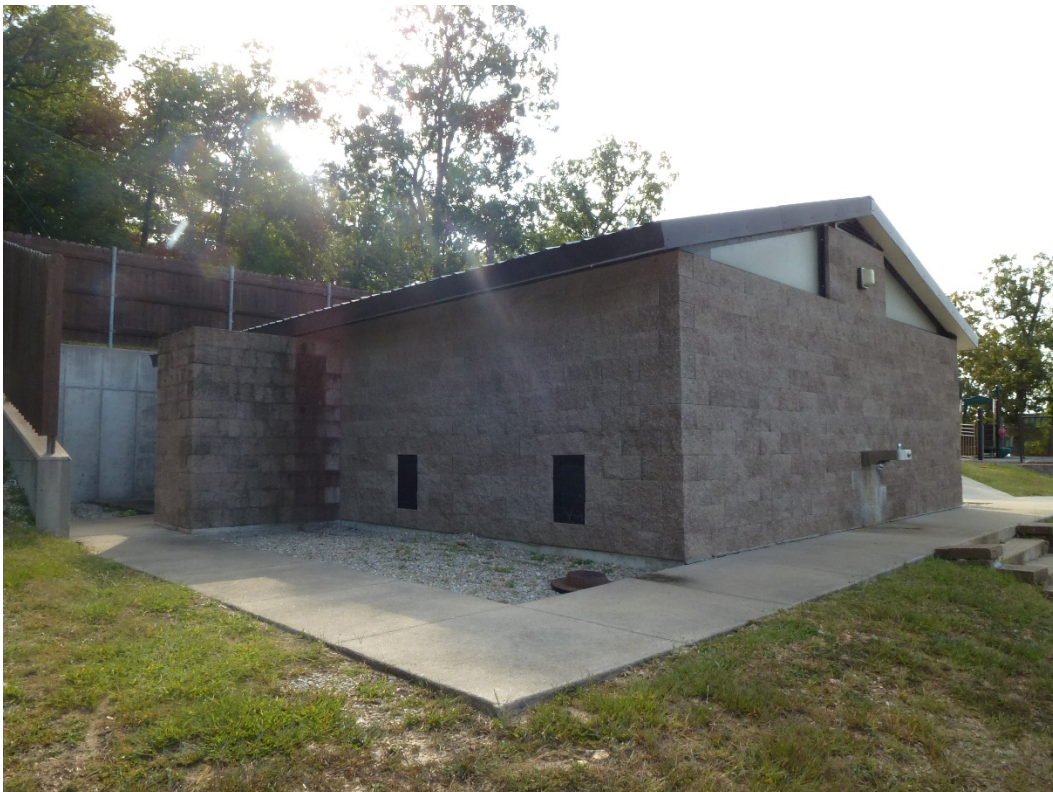
A few newer structures have been built at LORA. These supporting structures are constructed of concrete block with gable metal roofs. Building 529 (latrine) is located on the northeast side of Building 500 (NAF sales outlet) off of Olney Circle (Figure 132). The new building replaced a previously demolished latrine. Another concrete building was built near the newly constructed play structure near the helipad and boat-launching ramp. This building was constructed as a larger bath house (Figure 133). A poured concrete retaining wall supports the slope of the hill on the east side of the building. There was no number on the building to indicate what Building number it was.

Figure 133. Newer bath house facility located near the boat launch (ERDC-CERL, 2015).
